Hickman-Fulton Co. Riverport

Preliminary Engineering Report

**Re: Preliminary Engineering Report
625 Catlett Street, Hickman, KY 42050**

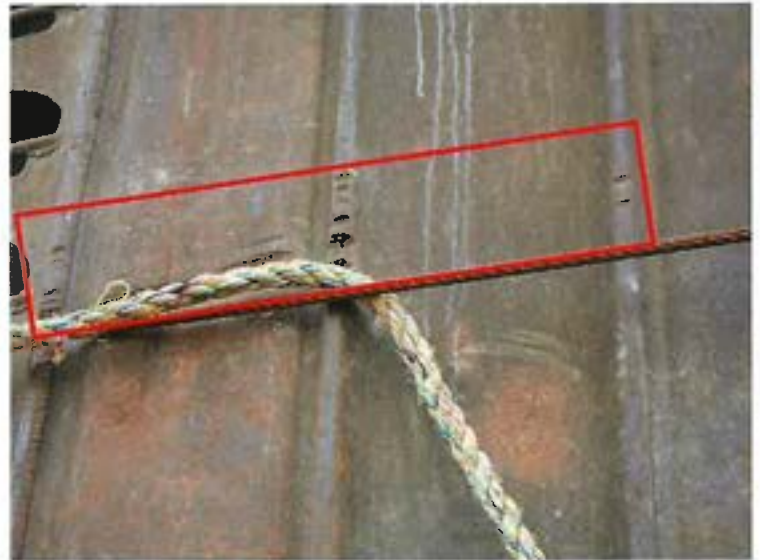
Photo 5: Sheets 46 to 1, abrasion damage from haul line

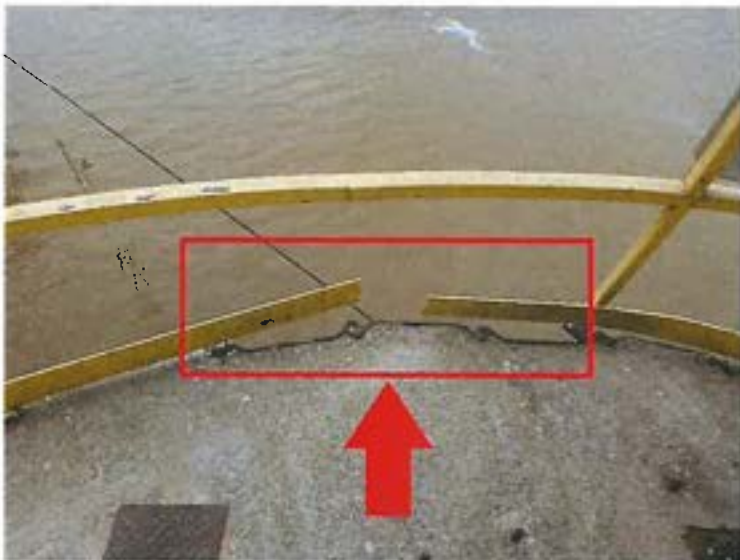
Photo 8: View of a broken toe kick over Sheet 41.

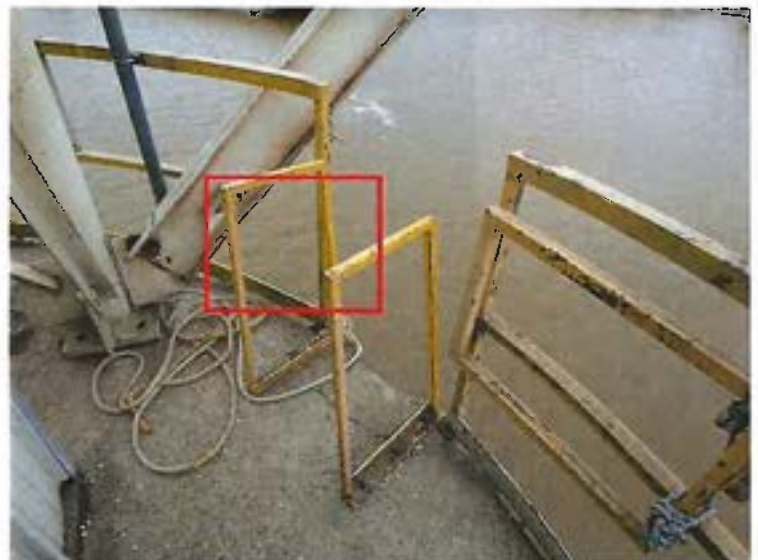
Photo 9: View of the missing safety chain over Sheet 1.

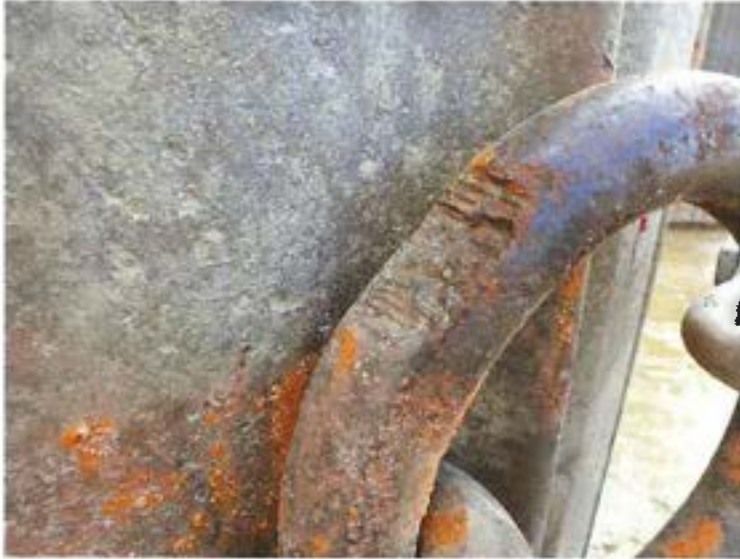
Photo 6: View of a missing section on the mooring ring.

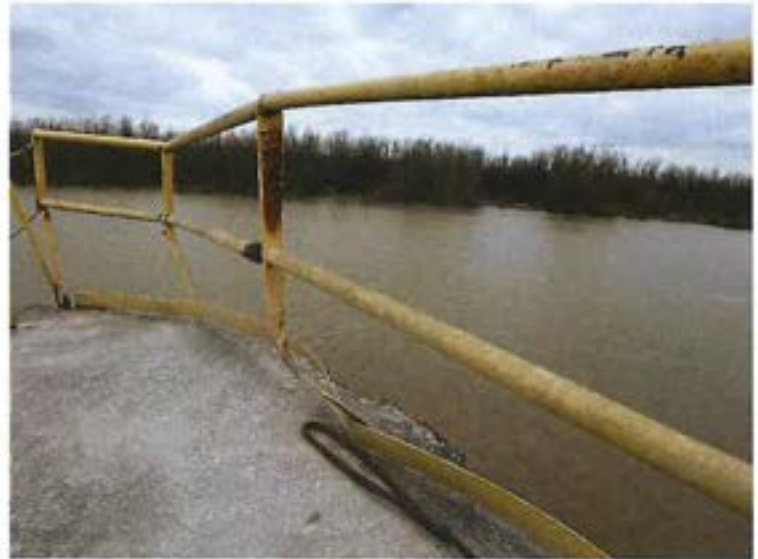
Photo 7: View of the impacted handrail.

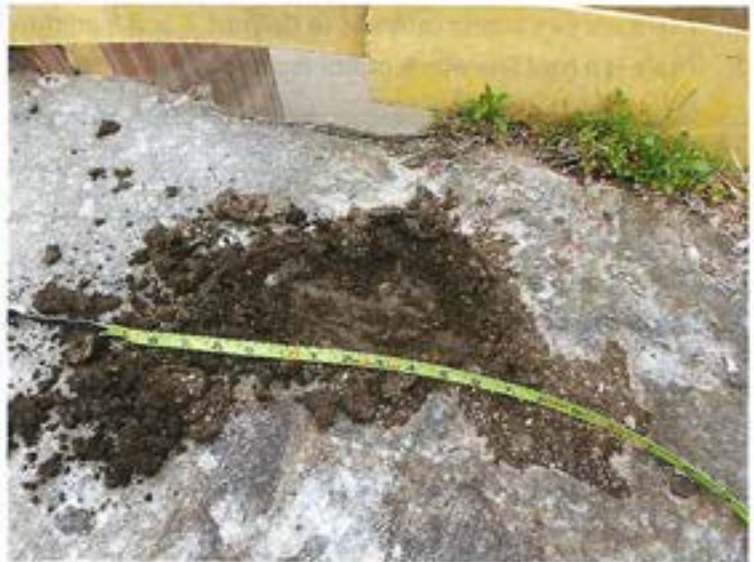
Photo 3: View of the spall in the cell cap.

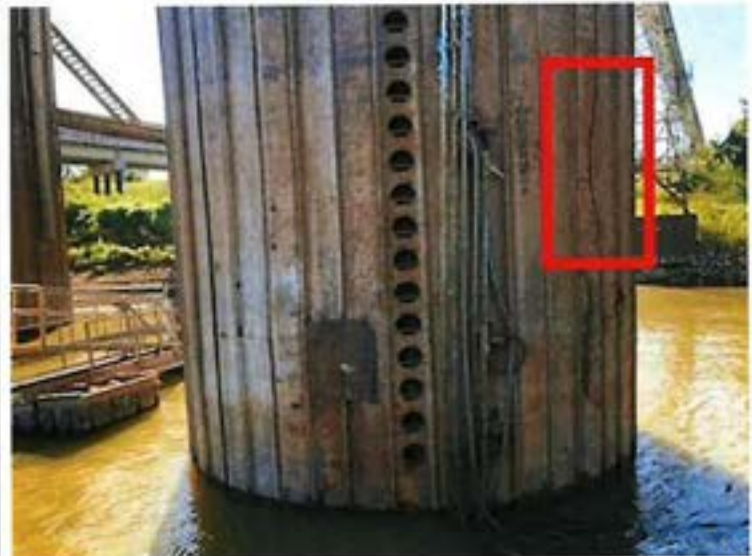
Photo 10: View of the impact damage on Sheets 43 and 44 (2021).

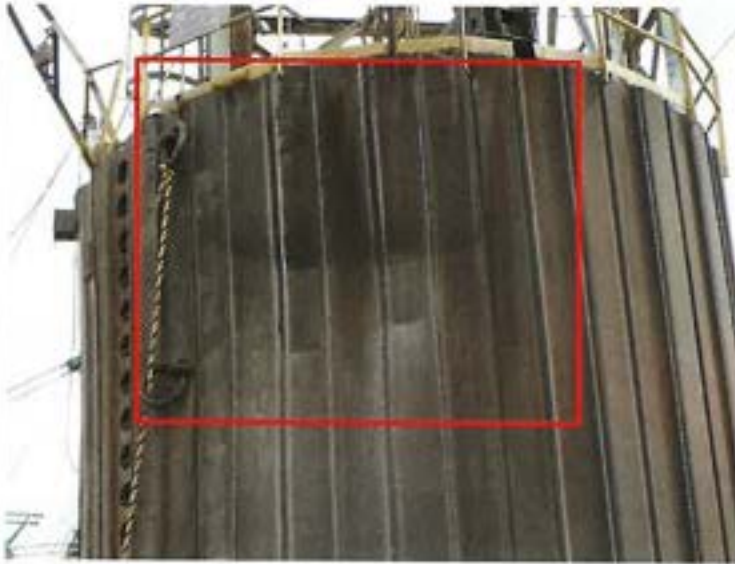
Photo 11: View of the impact damage on Sheets 41 to 46.

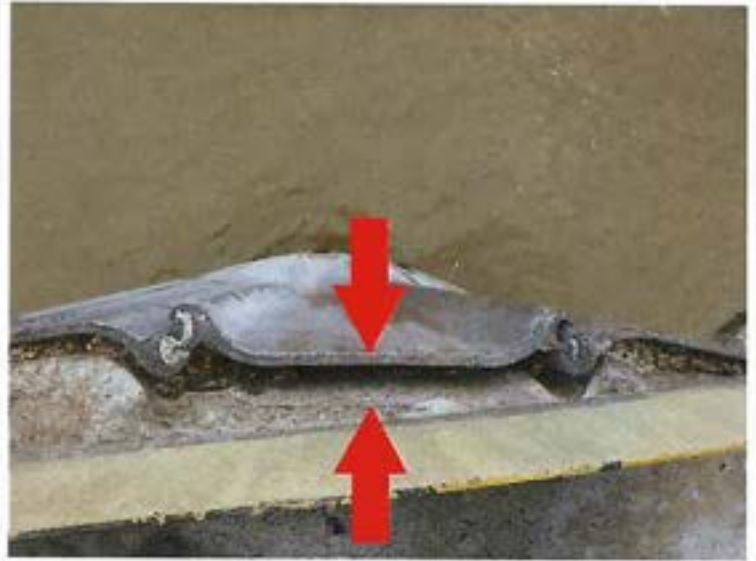
Photo 12: View of the gap between the sheet piles and cap.

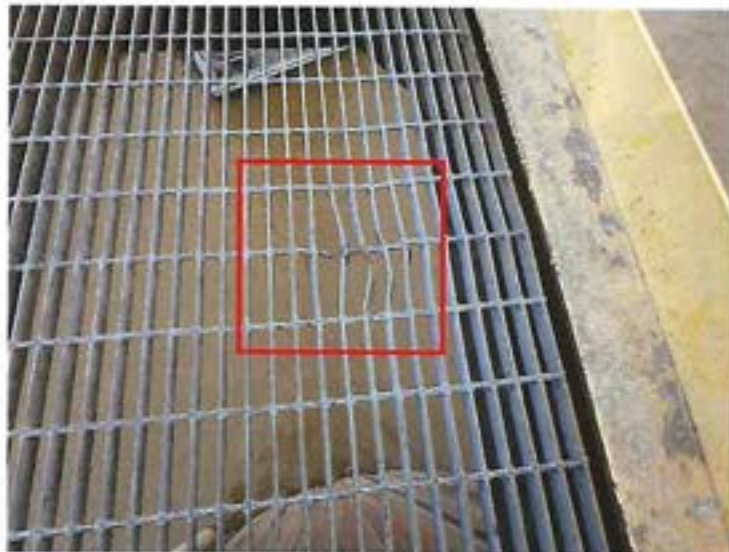
Photo 13: View of the broken grating on the walkway.

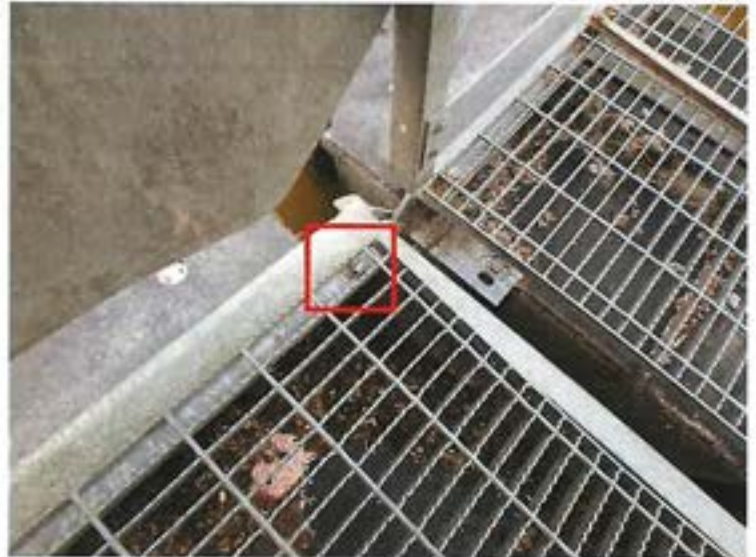
Photo 5: View of the missing grating clip on section 1.

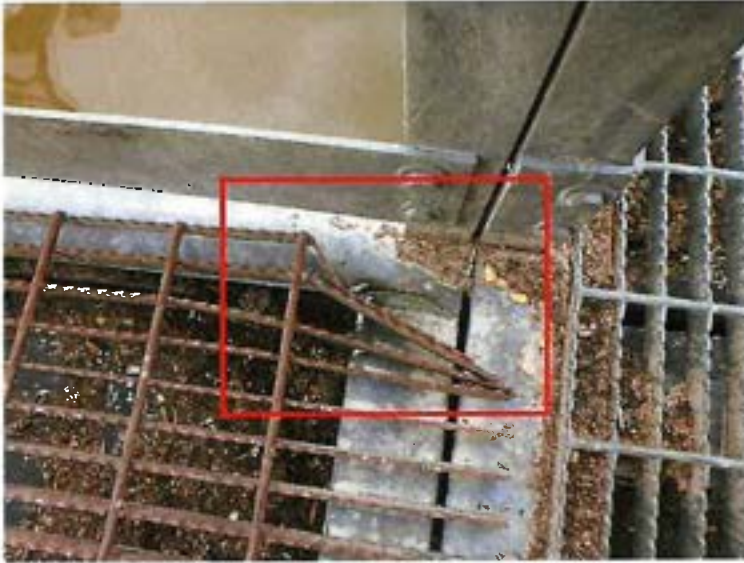
Photo 6: View of damaged framing and grating.

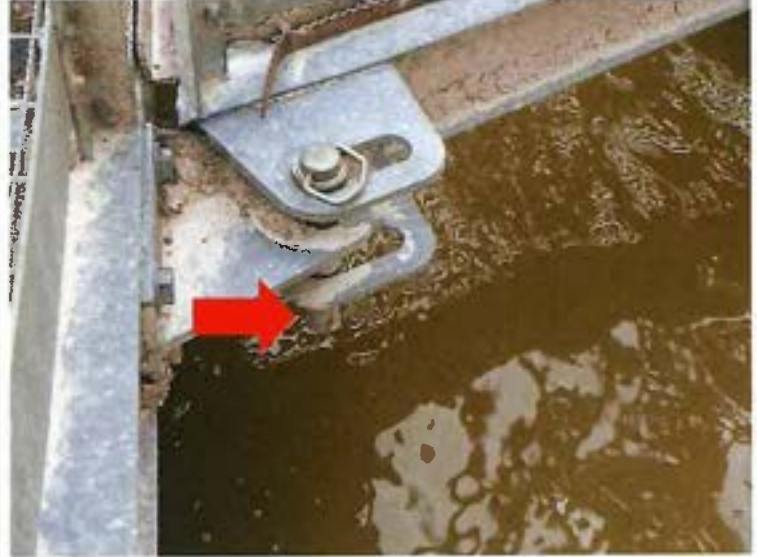
Photo 7: View of the missing lynch pin.

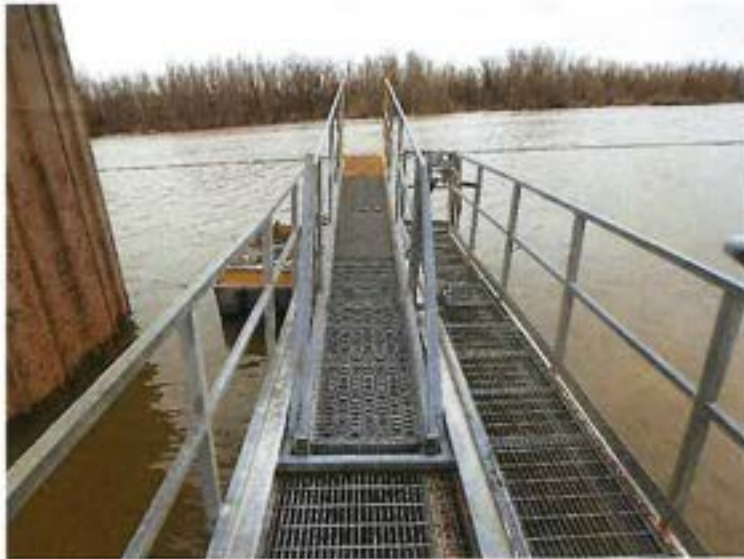
Photo 8: View of Section 3 listing to the downstream side.
