Hickman-Fulton Co. Riverport

Preliminary Engineering Report

**Re: Preliminary Engineering Report
625 Catlett Street, Hickman, KY 42050**

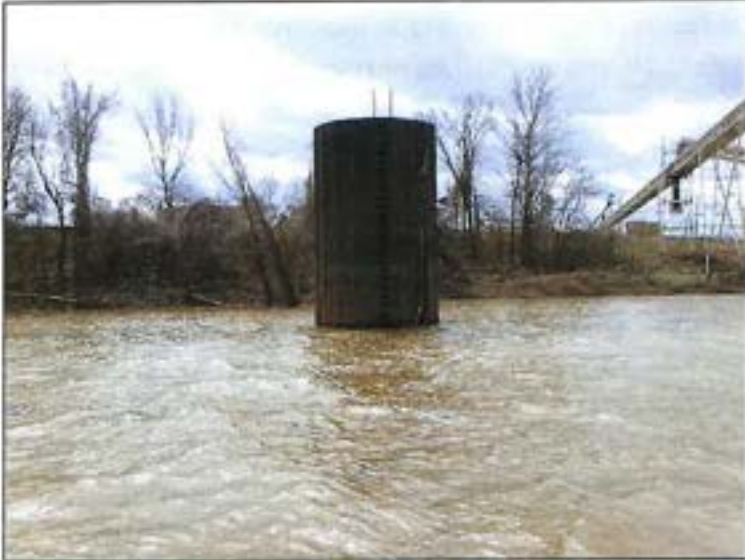
Photo 1: Elevation – Channel Side

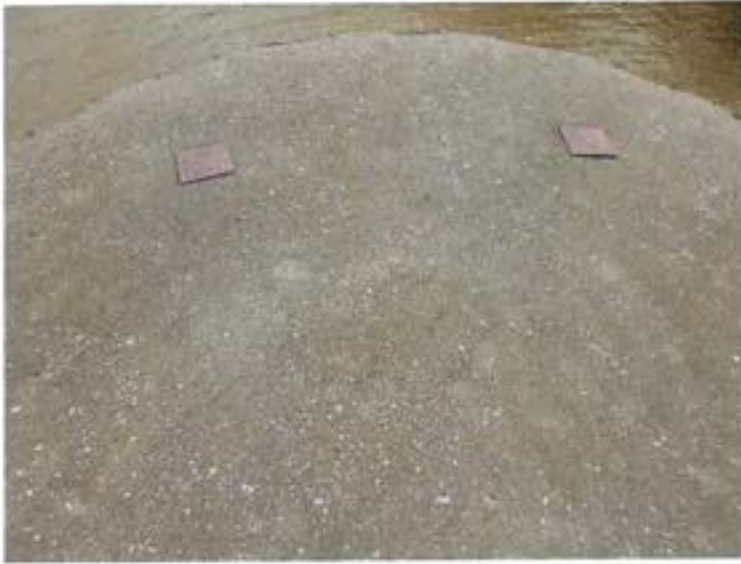
Photo 2: View of the concrete cell cap.

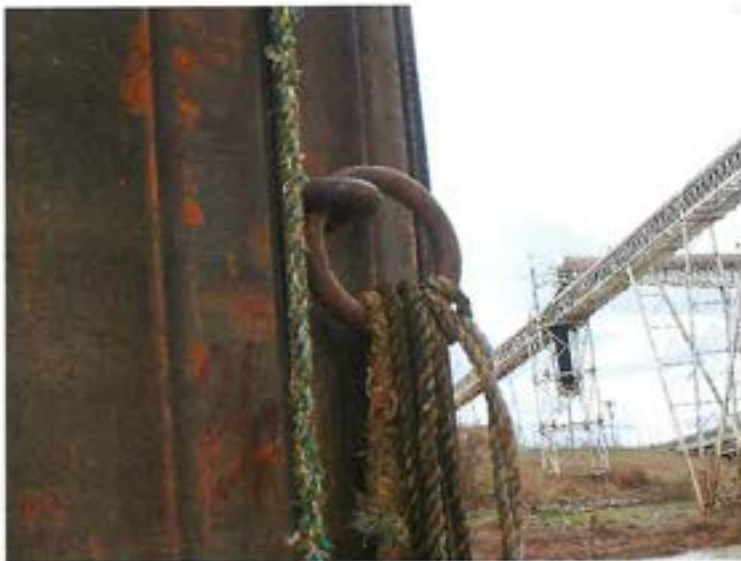
Photo 4: View of a typical mooring ring.

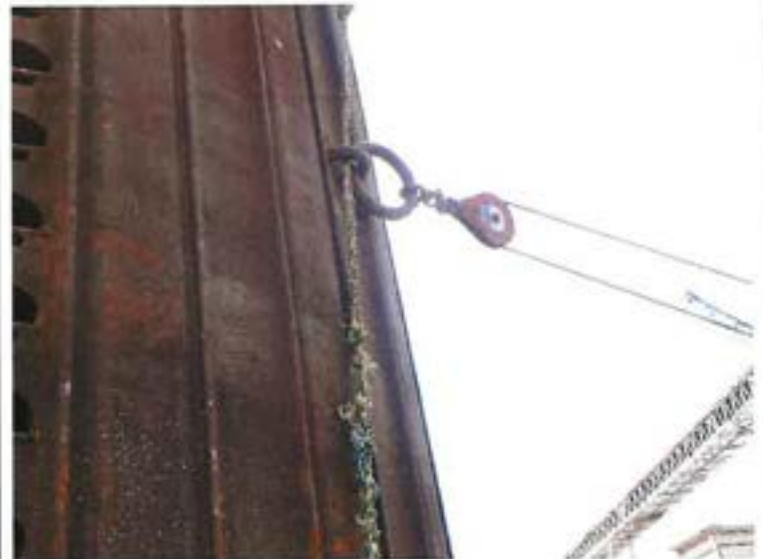
Photo 5: View of the haul line attached to the mooring ring at elevation 310 feet NGVD29.

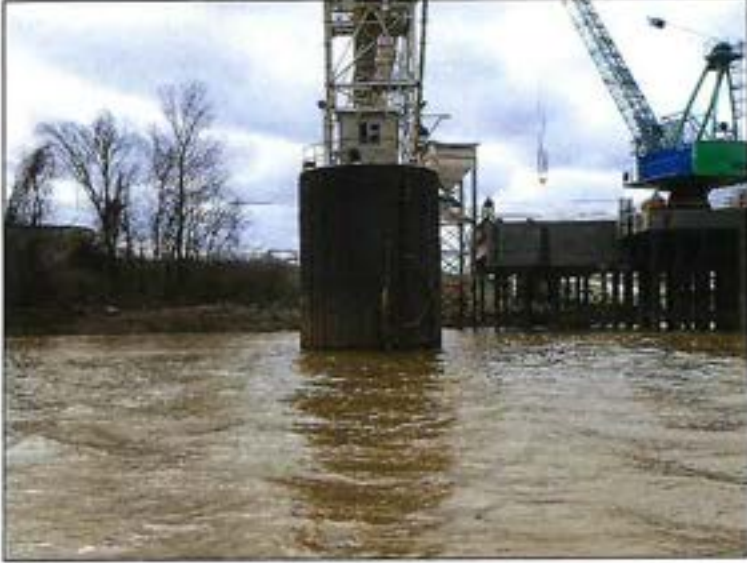
Photo 1: Elevation -- Channel Side

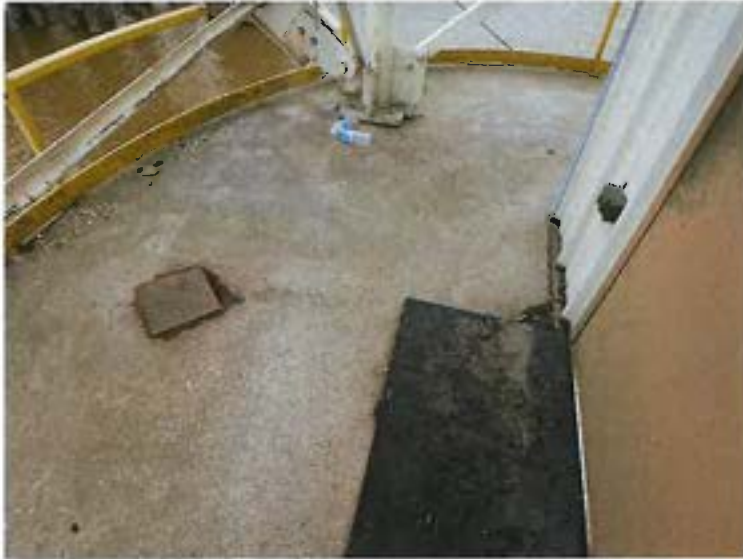
Photo 2: View of the concrete cell cap.

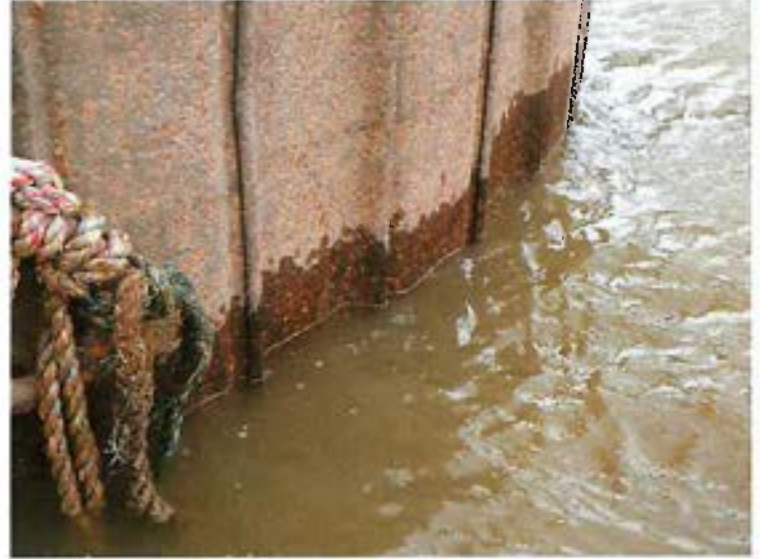
Photo 3: View of the typical sheet pile condition at the waterline.

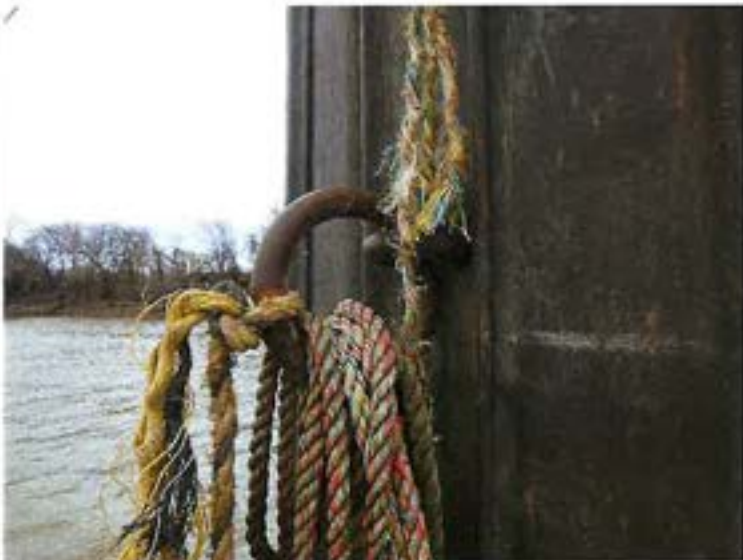
Photo 4: View of a typical mooring ring.

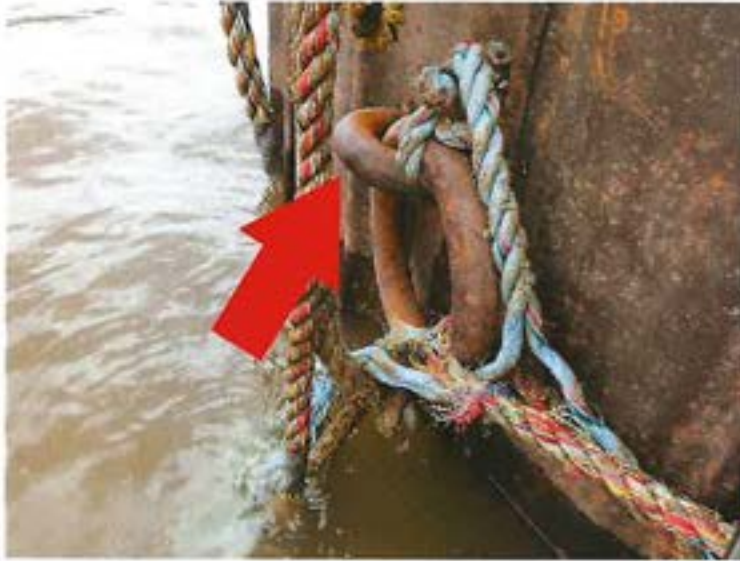
8. The interlock between Sheets 43 and 44 exhibits an area of impact damage at elevation 307 feet NGVD29 measuring 4-inches tall by 1.5-inches deep.
9. The U-bolt on Sheet 3 at elevation 295 feet NGVD29 has been impacted and deformed upwards.

Photo 6: View of impacted U-bolt on Sheet 3.

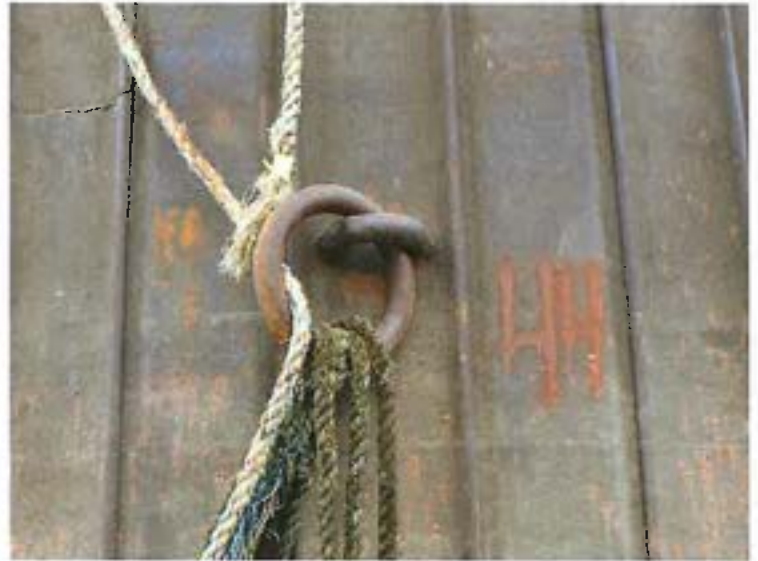
10. The mooring rings on Sheet 45 at elevations 301 and 295 feet NGVD29 are overstressed.
11. The toe kick above Sheet 41 is broken.
12. The safety chain above Sheet 1 is missing.

Photo 7: View of overstressed mooring ring on Sheet 45.

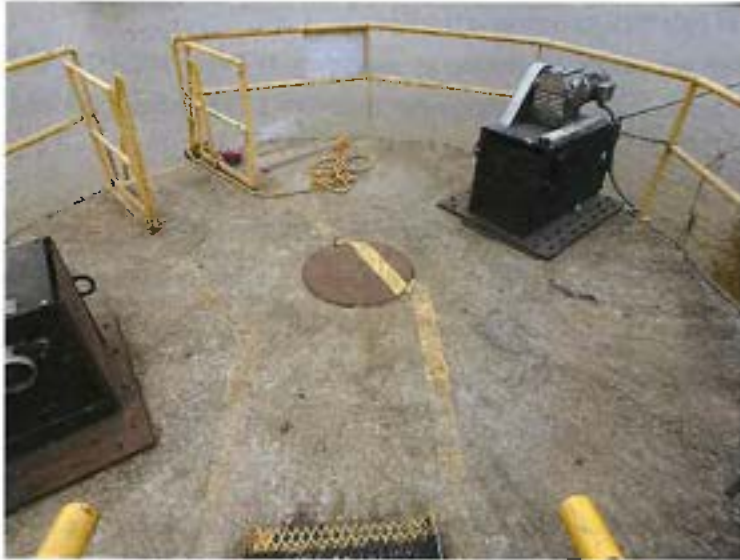
Photo 2: View of the concrete cell cap.

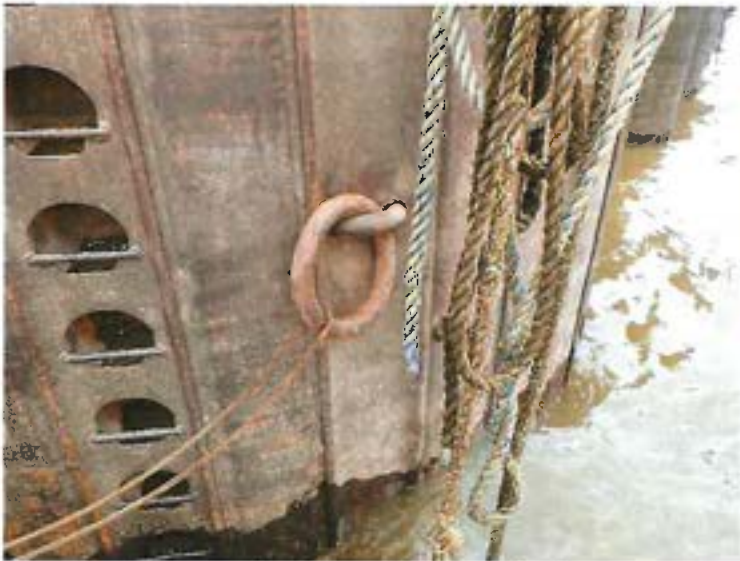
Photo 4: View of a typical mooring ring.

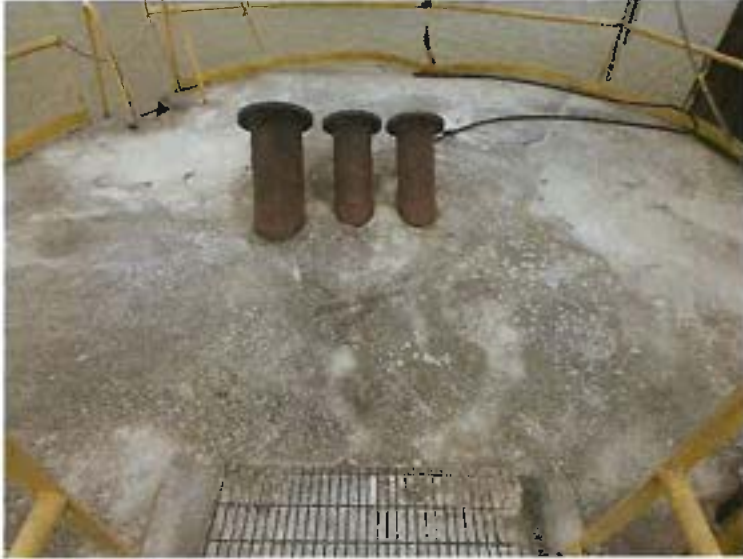
Photo 2: View of the concrete cell cap. Note the abandoned steel lines running into the cell cap.

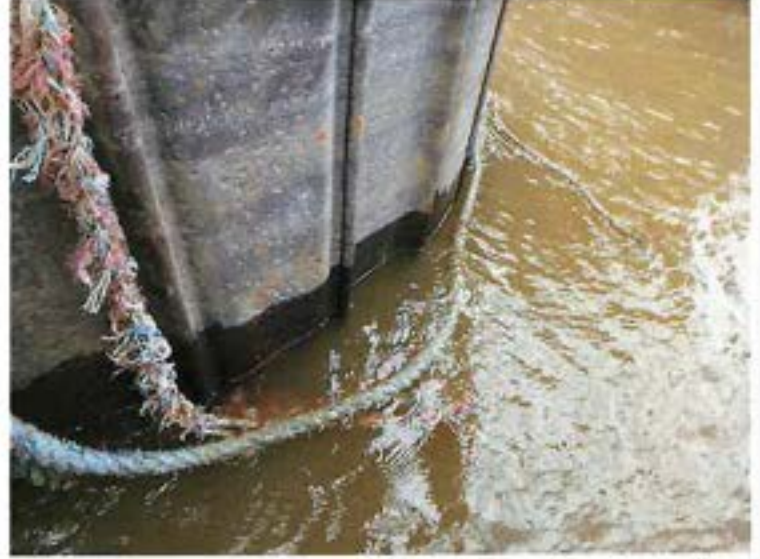
Photo 3: View of typical sheet pile condition at the waterline.

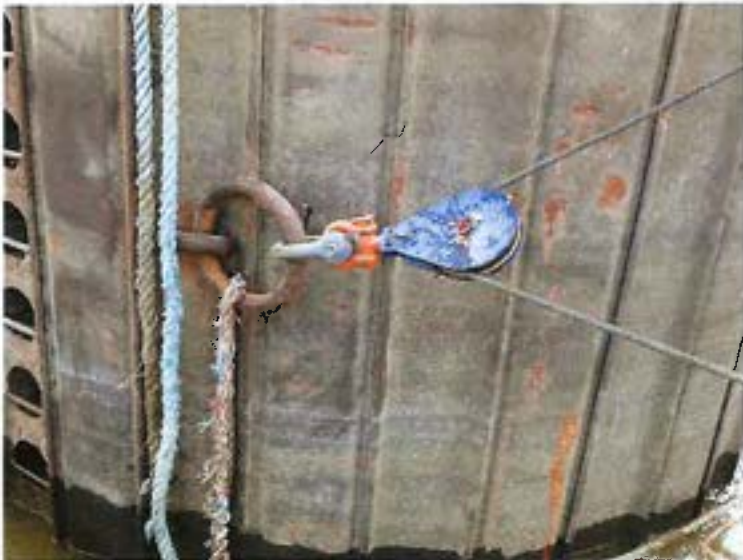
Photo 4: View of a typical mooring ring and haul line attachment.

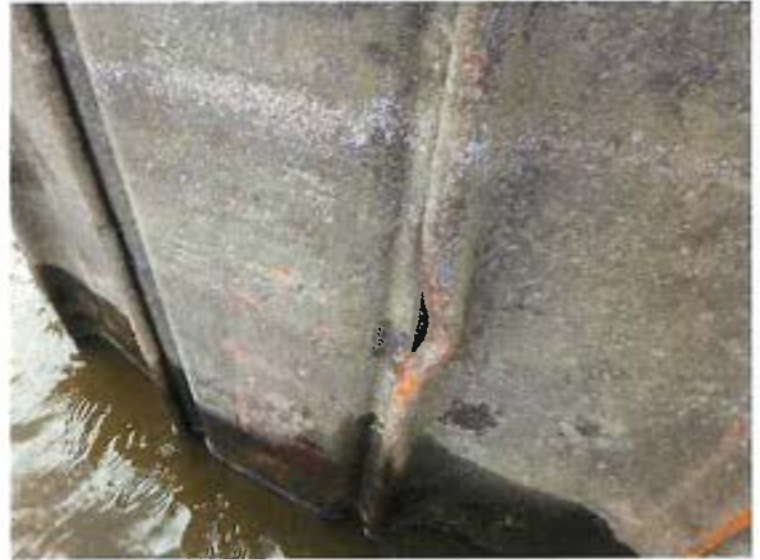
Photo 5: View of the open interlock between Sheets 3 and 4.

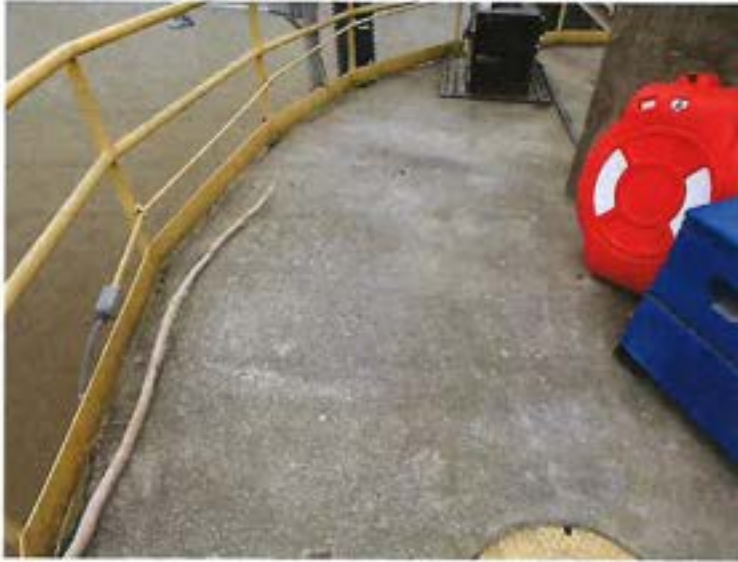
Photo 2: View of the concrete cell cap.

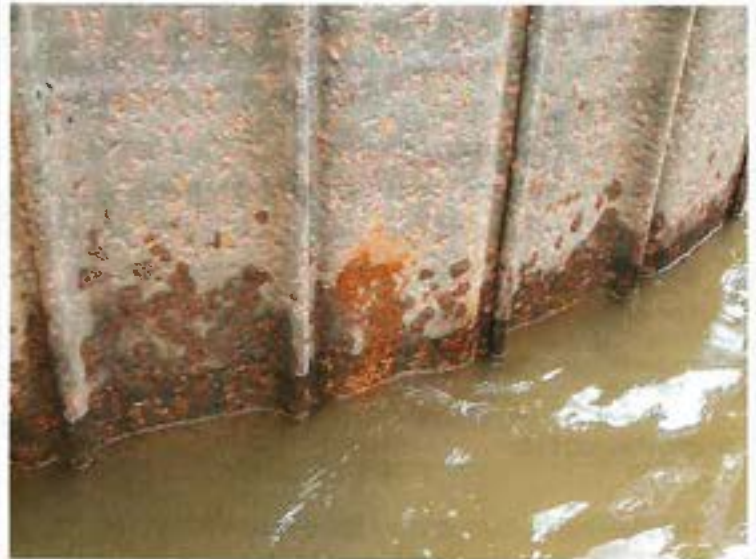
Photo 4: View of the typical sheet pile condition at the waterline.

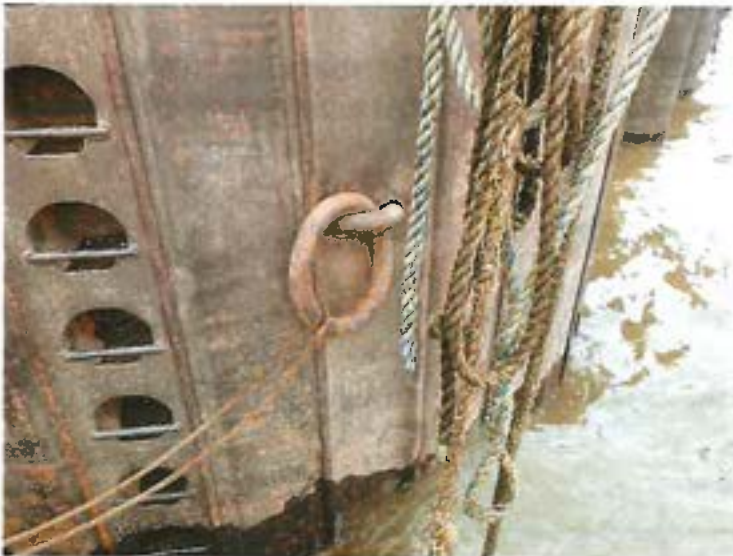
Photo 5: View of a typical mooring ring.

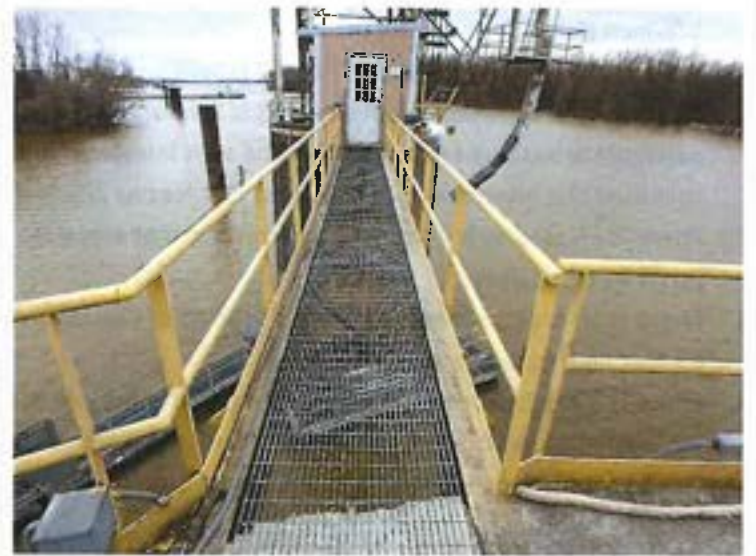
Photo 6: View of the access walkway from Cell 5.

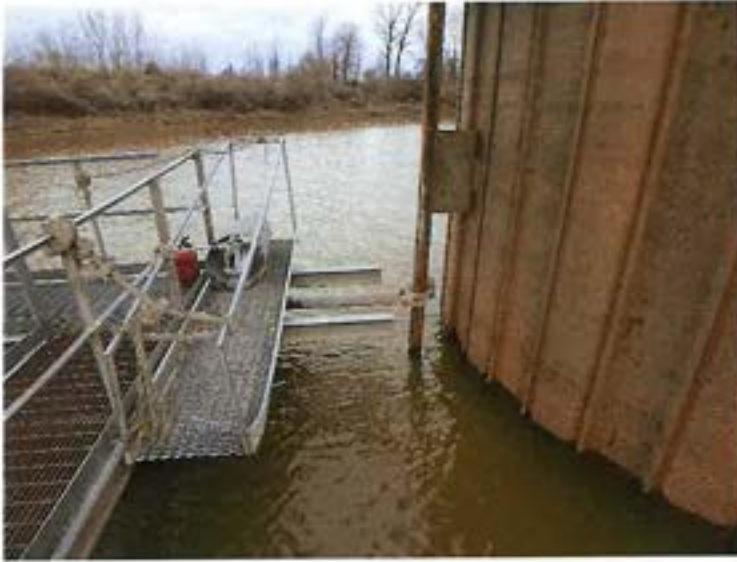
Photo 7: View of the floating dock guide pile.

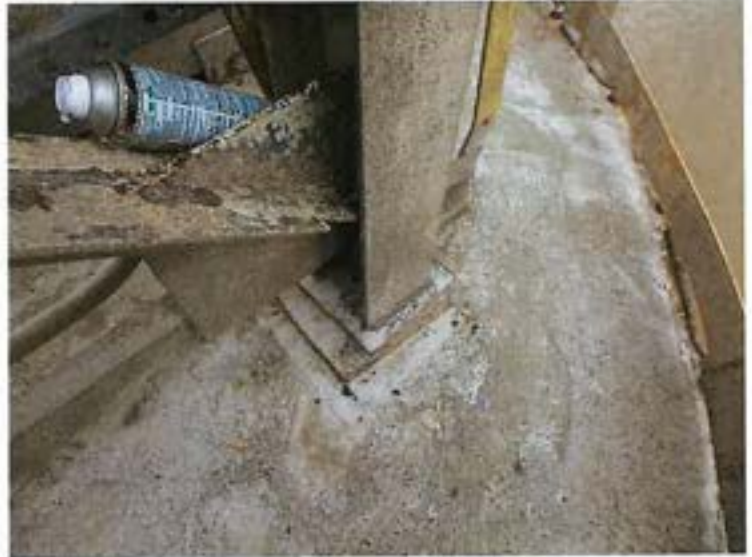
Photo 8: View of a support for the loadout conveyor.

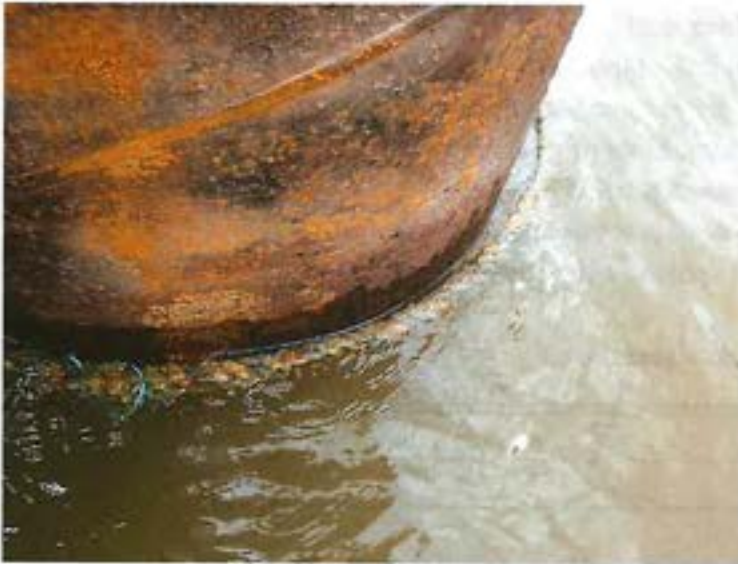
1. The channel bottom around the dolphin consists of silt.
2. The dolphin exhibits rust nodules up to 1-inch diameter by 1-inch thick with pitting up to 1/8-inch deep from elevation 292.0 feet NGVD29 to the channel bottom.
3. The upstream and channel faces of the dolphin exhibit multiple shallow impact spalls less than 1-inch deep throughout.
4. The mooring ring at elevation 296 feet NGVD29 is overstressed.
5. The ladder on the downstream face is impacted and deformed for its full height.

Photo 2: View of typical dolphin condition at waterline.

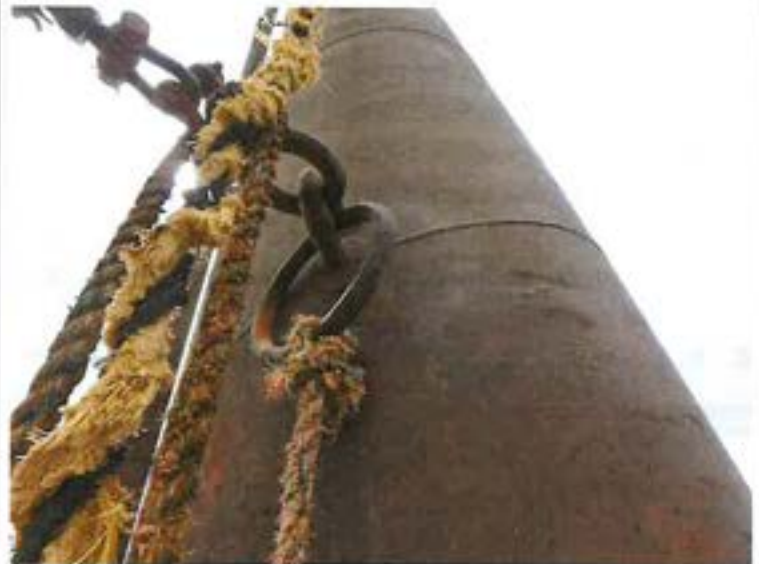
Photo 4: View of a typical mooring ring.

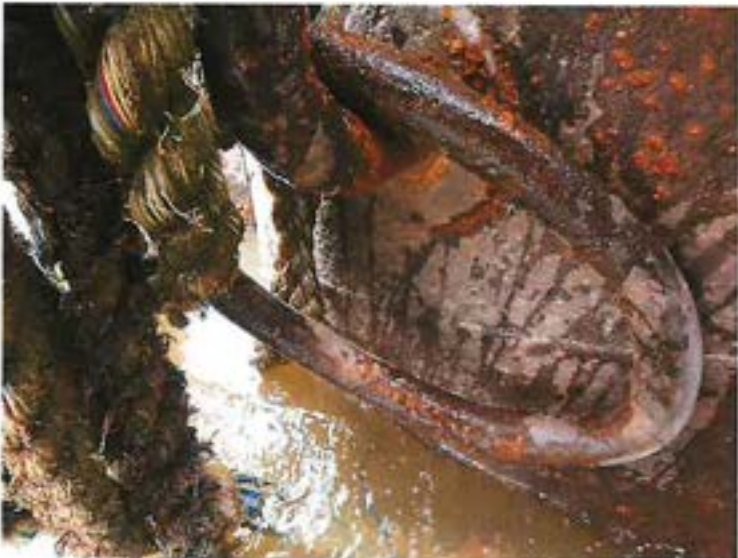
Photo 3: View of the overstressed mooring ring at El. 296 feet.

Dolphin 1 is in Satisfactory condition. Dolphin is located at the upstream end of the terminal. The dolphin consists of a 60-inch outer diameter spiral-welded pipe pile. The pile has moderate corrosion with at least 82 percent remaining section, with rust nodules up to 1-inch diameter by 1-inch thick and pitting up to 1/8-inch deep present below elevation 292 feet NGVD29. One of the mooring rings is overstressed. The externally-mounted ladder to the top of the dolphin is impacted and not useable. It is recommended that the overstressed mooring ring be replaced with a forged mooring ring on a medium priority basis, and the ladder be replaced on a low priority basis.

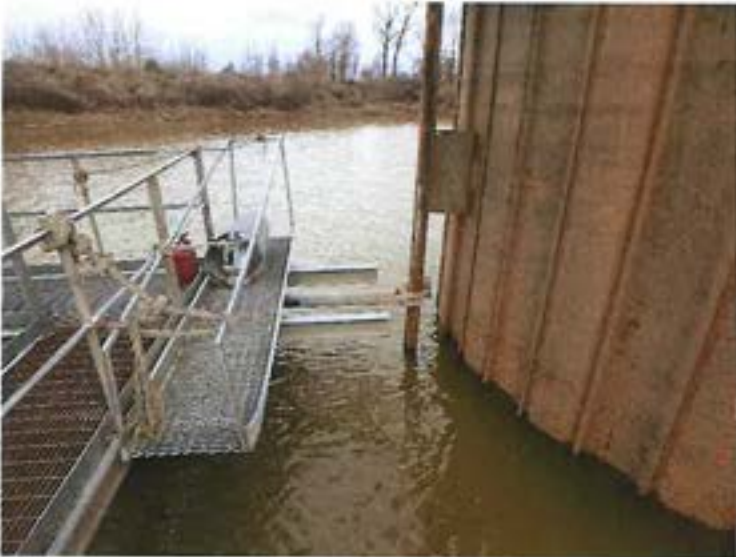
Photo 4: View of the guide pile.

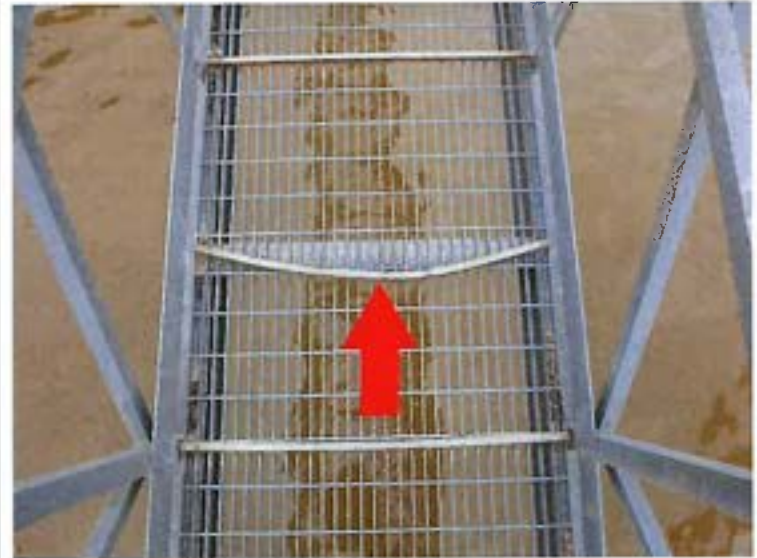
CONDITION NOTES:
<ol style="list-style-type: none">1. Section 1 has a missing grating clip at the downstream/bank corner.2. Section 2 has an area of broken grating framing and damaged grating at the upstream/bank corner.3. The transition between Sections 2 and 3 has a missing lynch pin for the keeper pin at the downstream/channel corner.4. Section 3 is listing towards the downstream side by 4-inches. The list is due to unequal loading.5. The gangway has multiple bent traction bars; however, the traction bars are still secure and functional.

Photo 9: View of a typical bent traction bar.
