Hickman-Fulton Co. Riverport

Preliminary Engineering Report

**Re: Preliminary Engineering Report
625 Catlett Street, Hickman, KY 42050**

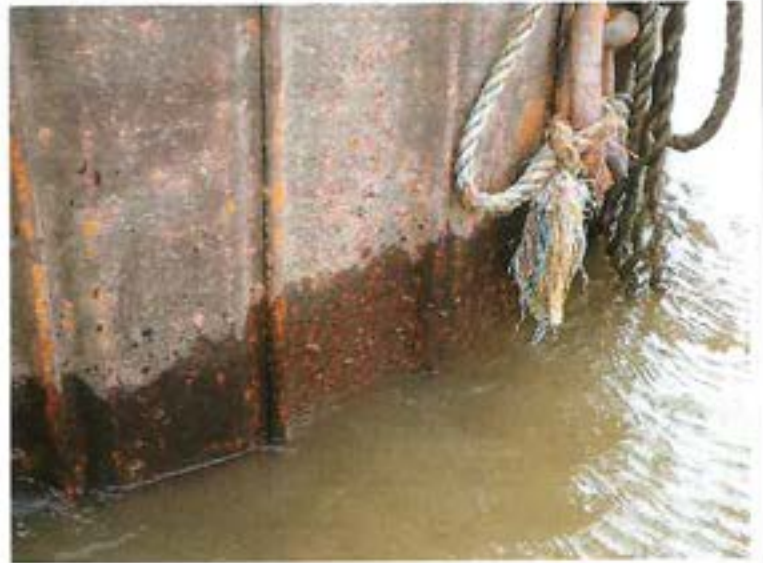
Photo 3: View of the typical sheet pile condition at the waterline.

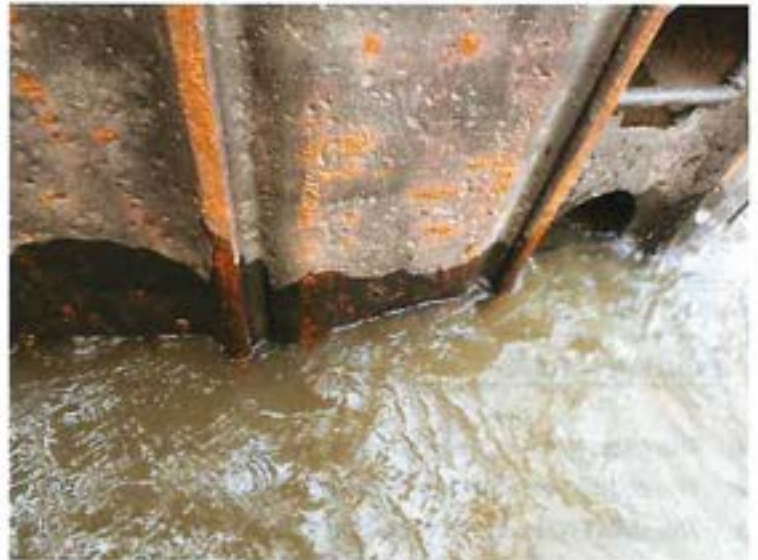
Photo 3: View of typical sheet pile condition at the waterline.

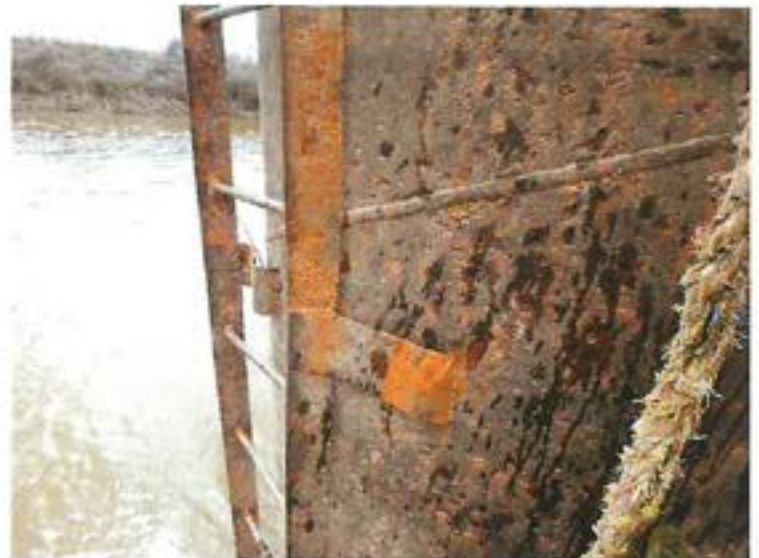
Photo 5: View of impacted ladder.

Dolphin 1 is in Satisfactory condition. Dolphin is located at the upstream end of the terminal. The dolphin consists of a 60-inch outer diameter spiral-welded pipe pile. The pile has moderate corrosion with at least 82 percent remaining section, with rust nodules up to 1-inch diameter by 1-inch thick and pitting up to 1/8-inch deep present below elevation 292 feet NGVD29. One of the mooring rings is overstressed. The externally-mounted ladder to the top of the dolphin is impacted and not useable. It is recommended that the overstressed mooring ring be replaced with a forged mooring ring on a medium priority basis, and the ladder be replaced on a low priority basis.

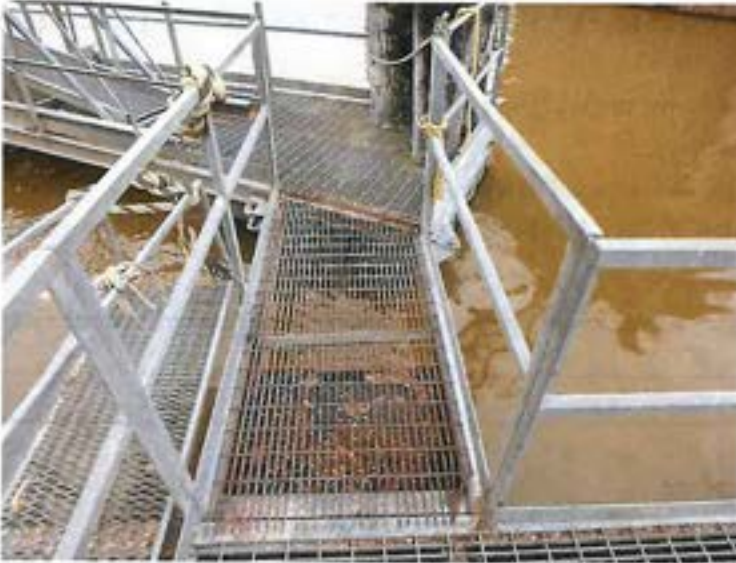
Photo 2: View of typical floating dock configuration.

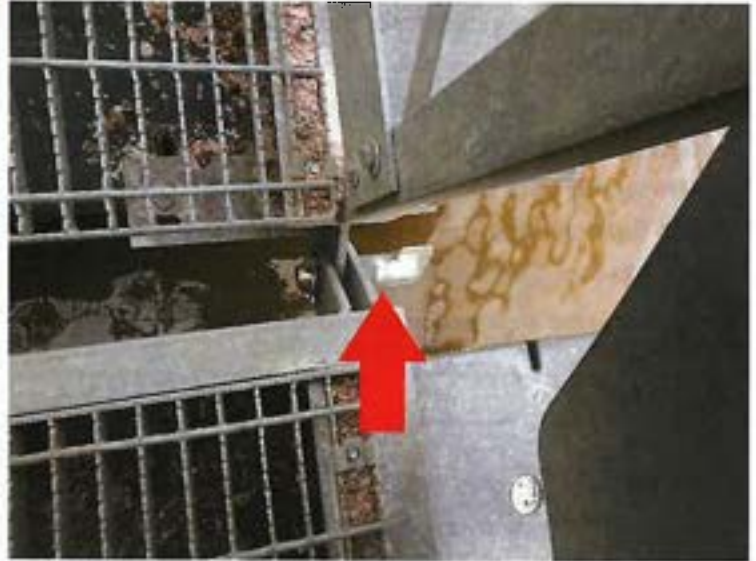
Photo 3: View of a typical keeper pin.
